Structural Fatigue in the 34-Meter HA-Dec Antennas

R. A. Van Hek and B. P. Saldua
Ground Antenna and Facilities Engineering Section

Structural modifications to the 34-m hour-angle-declination antennas, coupled with the use of the antennas beyond their intended lifespans, have led to structural fatigue, as evidenced by damage to the declination drive gear and cracks on the structural members and gussets. An analysis and simulation were made of the main antenna structural members. The analysis showed that the total stress to the antenna structure substantially exceeds the maximum levels recommended by the American Institute of Steel Construction (AISC). Although each of the separate static conditions of stress is only 50 percent of the total stress and does not reach the AISC reduced yield limit, fatigue can and did occur, causing the material to crack in the weakest places.

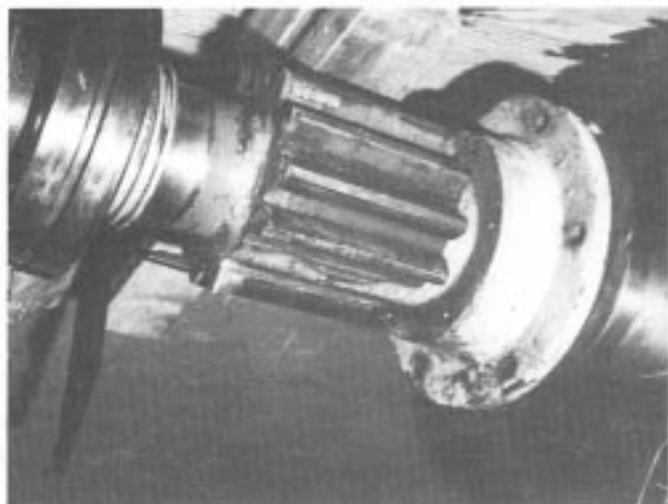
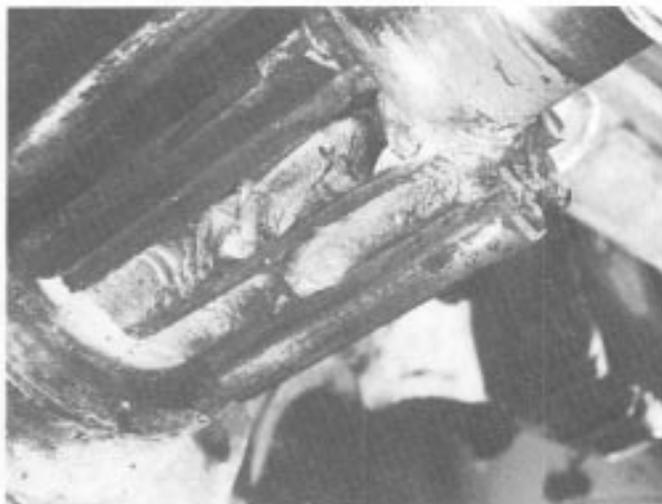
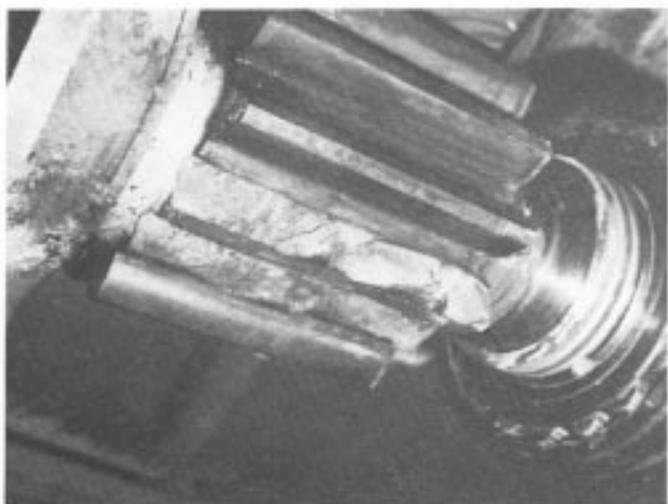
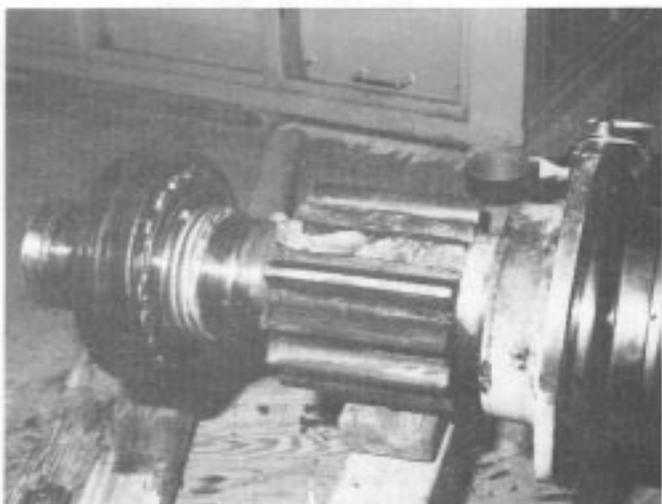
One of the most serious problems with the antenna is the excessive declination-axis bullgear-to-pinion separation that occurs as the antenna is moved from the east to the west horizon. The gear mesh separates when the reflector points to the horizon because the counterweight bends the rim and gear downward, causing a large deflection of the declination wheel. This reduced gear-mesh engagement has twice sheared off the pinion teeth at the DSS 12 antenna and three times at the DSS 42 and 61 antennas (Figs. 1 and 2). The gear-mesh separation increases during high winds, so the antennas are currently stowed before the wind reaches 45 mph.

Fig. 1. Broken pinion teeth of declination wheel drives, DSSs 42 and 61.

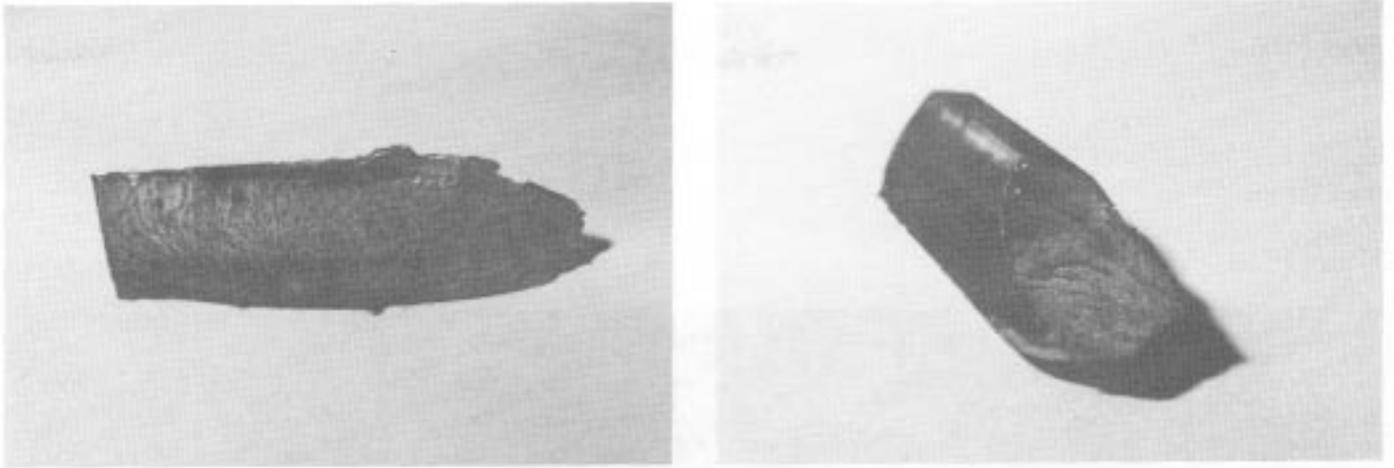
Fig. 2. Pieces of broken pinion teeth from the declination wheel drive, DSS 42.

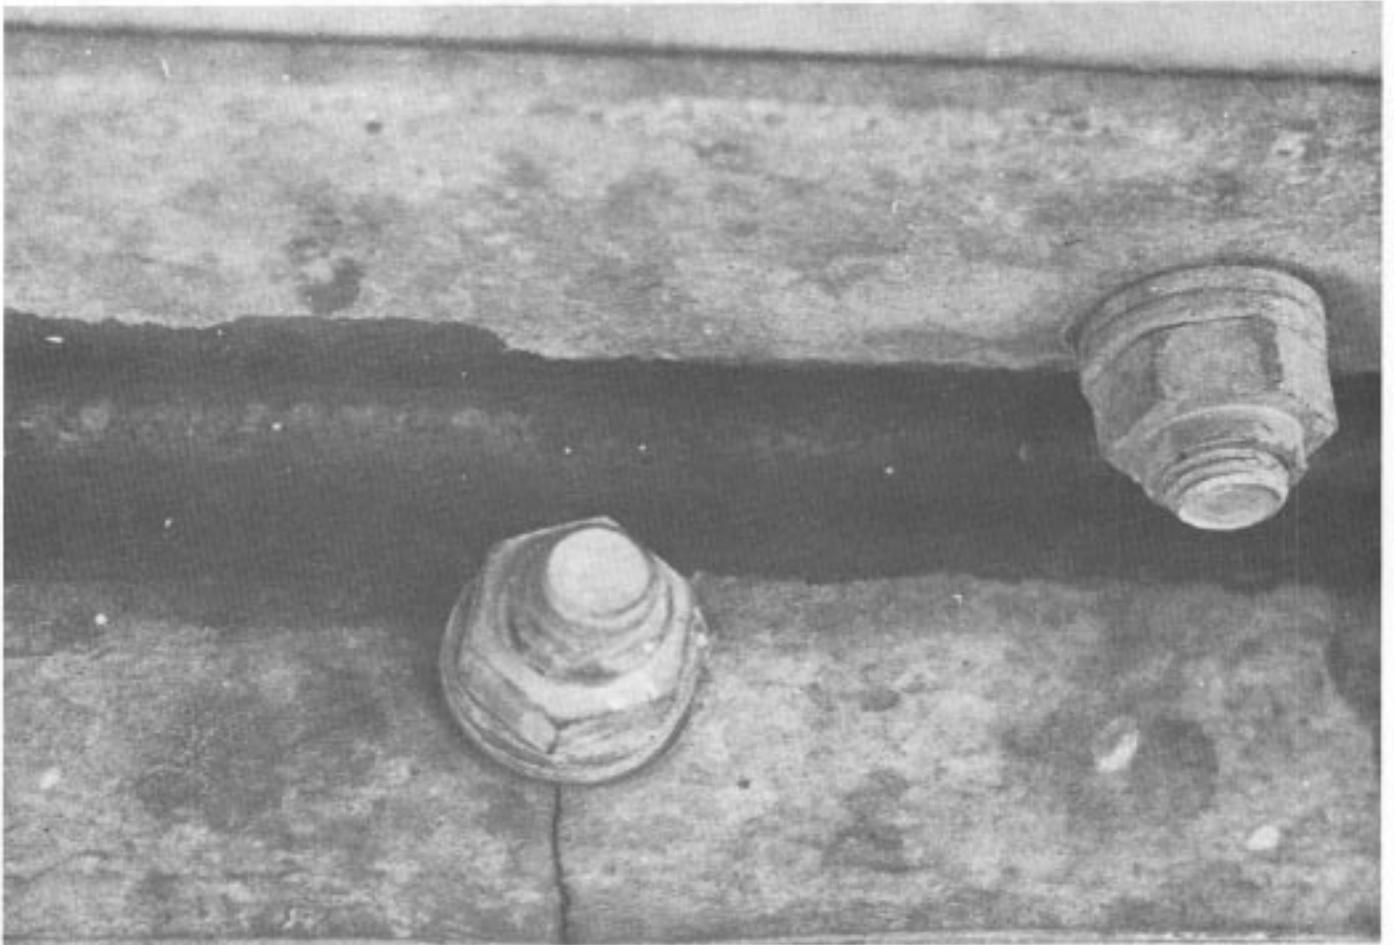
Until March 1989, no major problems were found on the HA-dec antenna structures except for small weld cracks and occasional sheared and loose bolts, mostly in the secondary members and their connections. In April 1989, additional cracked welds were discovered in more significant areas (e.g., see Fig. 3), but action was postponed until after the planned annual inspection in July 1989. A close watch was kept to see if the cracks were getting worse, and this continued until the annual inspection.

Fig. 3. Typical crack in the polar wheel structural member, DSS 12.

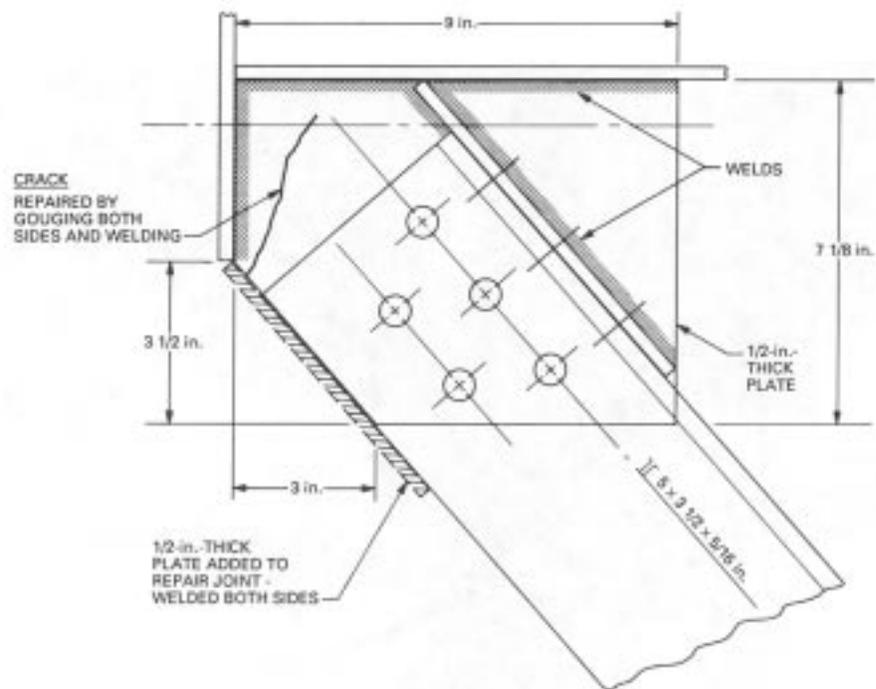
On the day of the annual inspection, May 25, 1989, a major failure was discovered at DSS 12; it must have occurred between April and May 25. The failure occurred in a gusset plate near the declination bearing. There are four such plates, and a crack developed in three of the four plates. The gusset plates connect primary members from the wheel rim to the bearings; these members support the weight of the counterweight and the dec house when the antenna is looking east or west (Figs. 4 and 5). The longest crack was 4 in. long (Figs. 6 and 7), while the two other cracks were only 0.5 in. long. All the cracks looked recent. (Note that the cracks were very similar to the gusset plate crack that caused the NRAO 300-ft antenna to collapse.)

Fig. 6. Failed joint detail drawing, DSS 12.

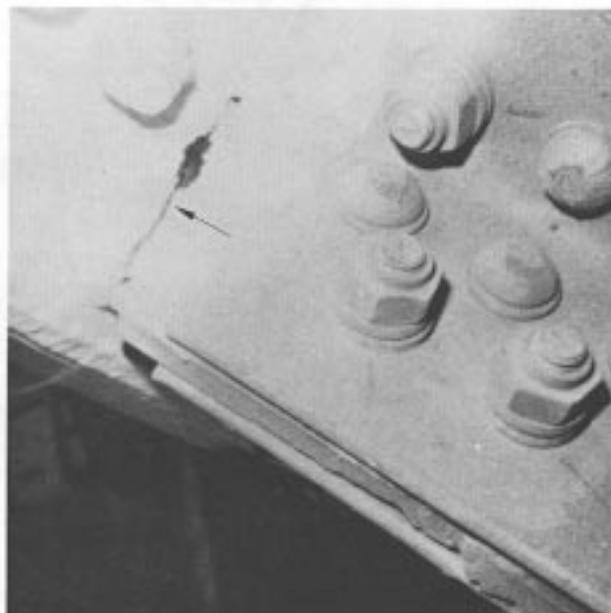
In addition, even if the critical stress levels were never reached, repeated loading and unloading might eventually result in failure. This phenomenon is known as "fatigue." In condition (2), where the loading is reversed from tension to compression and back again with an additional eccentricity in the connection causing a bending stress, fatigue is likely to occur. In fact the cracks in the plates occurred adjacent to the welding, where the parent material was weakened by weld undercuts.

Fig. 7. Cracked gusset, inboard side, DSS 12.

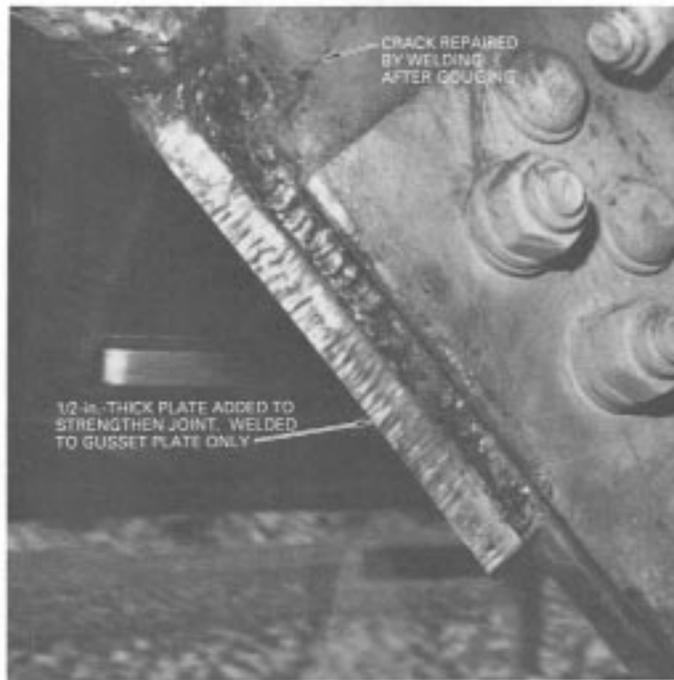
Fig. 8. Repair of failed joint, DSS 12.

Immediate action was taken to repair the gussets and reinforce the structural connections (Fig. 8). All minor repairs were also made at this time.

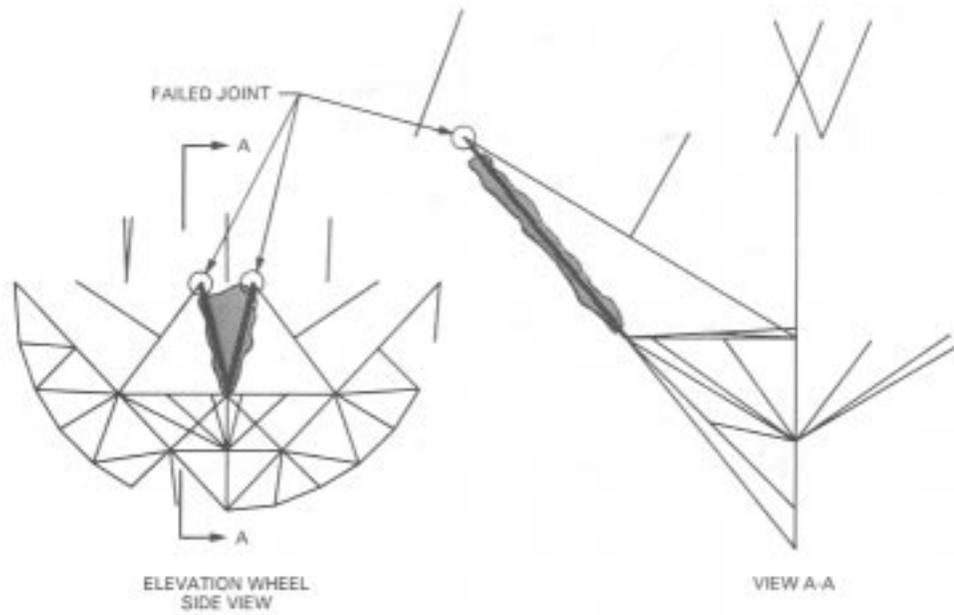
Fig. 9. Computer model of declination wheel.

The worst stresses occurred in loading condition (2) because a reversal of loads at the east or west position caused a reversal of stress in the members and their connections, which are the gusset plates. Thus the gusset plates are subject to stress reversals from (1) combined compressive stress plus bending stress due to eccentricity and (2) combined tensile stress plus bending due to eccentricity.
