Alignment of the Atmospheric Visibility Monitoring Telescope

K. Cowles and D. Erickson
Communications Systems Research Section

Alignment of the first Atmospheric Visibility Monitoring telescope has revealed errors in mount design, mount manufacture, software, and electronics. This article discusses error sources and solutions, and realignment results. Alignment requirements for operation are also presented. The telescope now operates with the desired accuracy and repeatability.

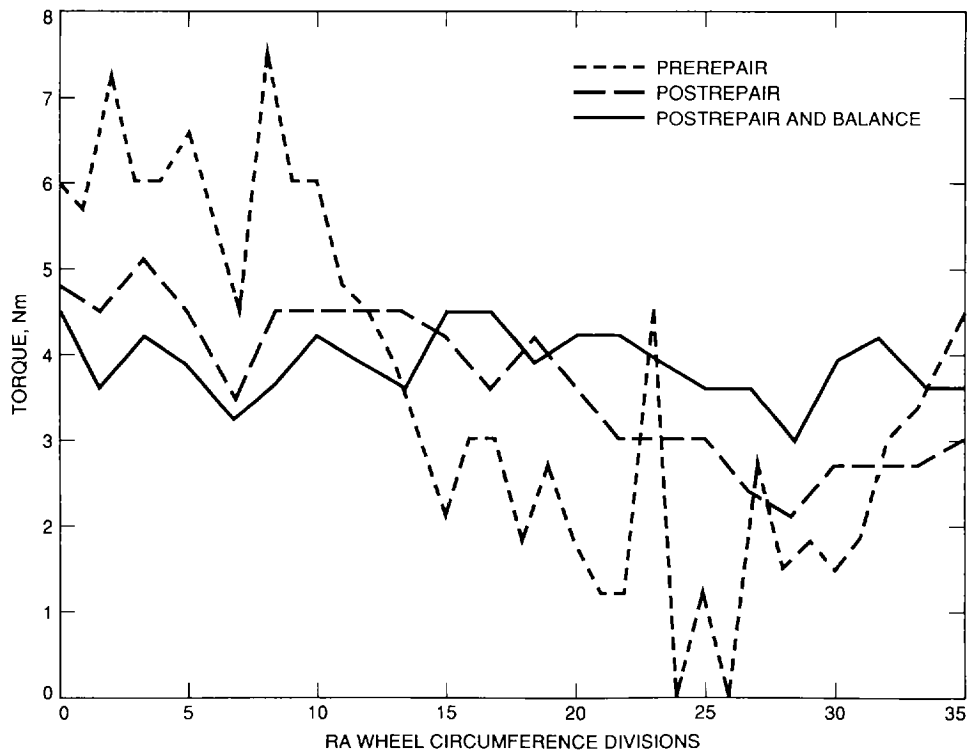
The right ascension wheel was balanced statically by measuring the torque required to move the wheel with a torque wrench. Magnetic counterweights were attached to the wheel in an attempt to compensate for torque differences. Some errors were not able to be eliminated using counterweights. These errors have been attributed to errors in the right-ascension wheel assembly, which was found not to be concentric with the South Pole bearing shaft. This caused uneven preloading, requiring more torque to turn the wheel at certain points. Figure 1 shows the torque necessary to move the right ascension wheel before it was repaired. The large peaks on the prerepair curve display the preloading effect. This error was also seen in alignment. When moving in right ascension where the wheel corresponded to a peak on the curve, larger positional errors were seen in locating the next star.

The curves in Fig. 1 showing conditions following repairs indicate that errors have been reduced by the ma-

chining of the right-ascension wheel. Balancing following the machining has resulted in a more even amount of torque necessary to drive the wheel.

Fig. 1. The torque necessary to move the right-ascension wheel before repair, after repair, and after repair and balancing.

The right-ascension wheel assembly for the third telescope was remachined by the manufacturer to repair a damaged surface. While under repair, it was discovered that the south-pole bearing shaft was not concentric with the right-ascension wheel. It was determined that the preloading of the right-ascension wheel on the first telescope was probably caused by a similar problem. The first and second right-ascension wheels were then sent for repair. These wheels were also found not to be concentric. The center of the wheel for the first telescope was off by $3/8$ in. Repairs were made to both of the wheels.

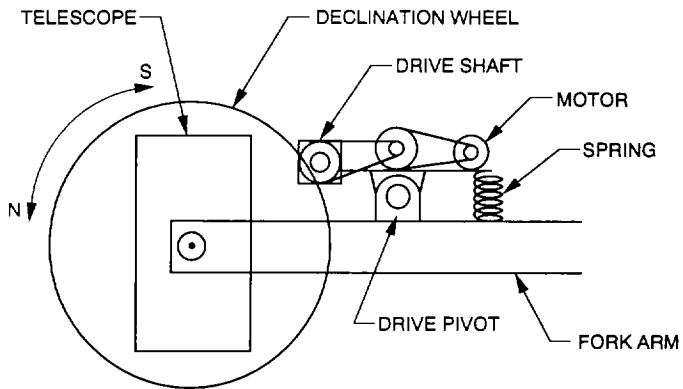
A static balance of the declination wheel was done separately from the alignment procedures. During the alignment procedures for the declination axis, the telescope appeared to be weighted more heavily to the south. Addition of weights to the north did not appreciably change the errors. Theoretically, if the telescope were heavier to the south, it would step too far south when moving south, and not far enough north when moving north. Changing the weights had little effect, however.

Fig. 2. Declination drive of the manufacturer's design.

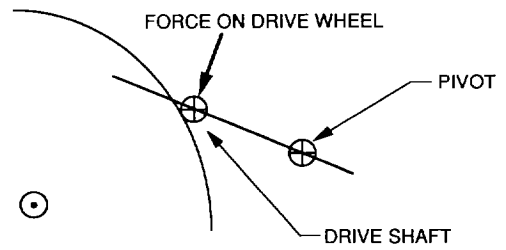
A compression spring preloads the drive shaft of the declination wheel. Decreasing the spring tension decreased the south-going error. If the spring tension was decreased to the point where there was still enough tension to drive the wheel without slippage, the telescope still pulled slightly to the south. By using counterweights and lowering the spring tension, the telescope could be moved between stars located between 20 deg N and 20 deg S with smaller errors. However, these errors were nonrepeatable, differing by up to 1.5 arcmin when traveling from north to south. This range limits the available area of the sky considerably. The problem has been attributed to improper preloading of the declination wheel, as seen in Figs. 2 and 3. Figure 2 shows the configuration of the declination drive. Figure 3 indicates the direction of force from the drive shaft onto the declination wheel. Figure 4 indicates the direction of the force that should be applied for proper preloading. Figure 5 indicates how the drive could be reconfigured to achieve this preloading.

Fig. 3. Directions of force on the declination drive of the manufacturer's design.

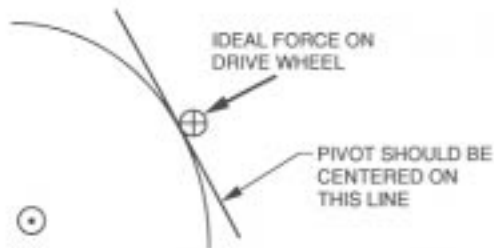
Fig. 4. Directions of force of the modified design for improved acquisition accuracy.

The declination motor assembly and motor shaft have been redesigned and rebuilt, as indicated in Figs. 2–5, to provide proper preloading. A photograph of the present configuration is shown in Fig. 6.

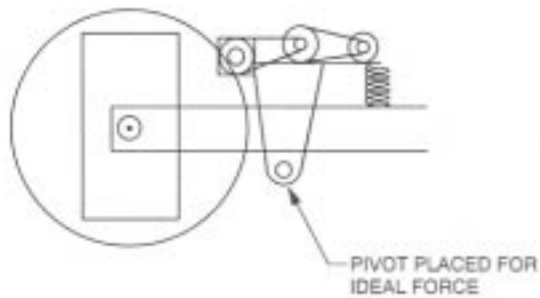
Fig. 5. Declination assembly configuration of the modified design for improved acquisition accuracy.
