Repair of the DSS-14 Pedestal Concrete

D. McClure

64-Meter Rehabilitation and Performance Upgrade Project

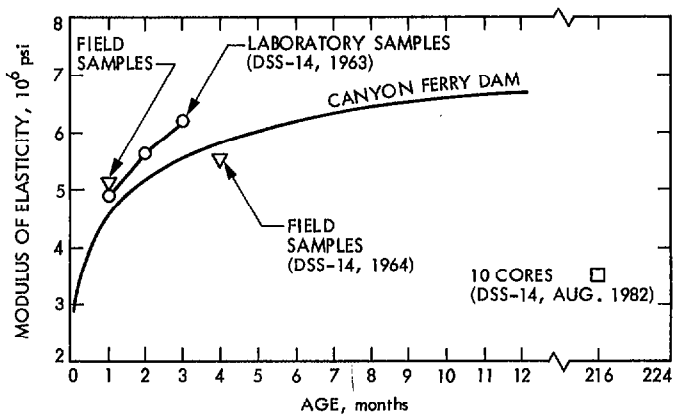
Fig. 3. Modulus of elasticity vs. time

Perhaps the most sobering event came with the measurement of the MOD E for the first cores removed in July 1982. Figure 3 shows the expected behavior of the MOD E with time. Very little data is available since the MOD E is not ordinarily a concrete design characteristic; concrete design engineers usually design for strength, not stiffness. Nevertheless, the measured values of less than 2 million to about 4 million psi were considerably less than the approximately 7 million psi expected. This was the first evidence that a serious problem was at hand. (It should be noted that there was no danger of the pedestal collapsing; the strength was more than adequate.) It was the declining stiffness that was alarming, for that could be contributing to the hydrostatic bearing problem.

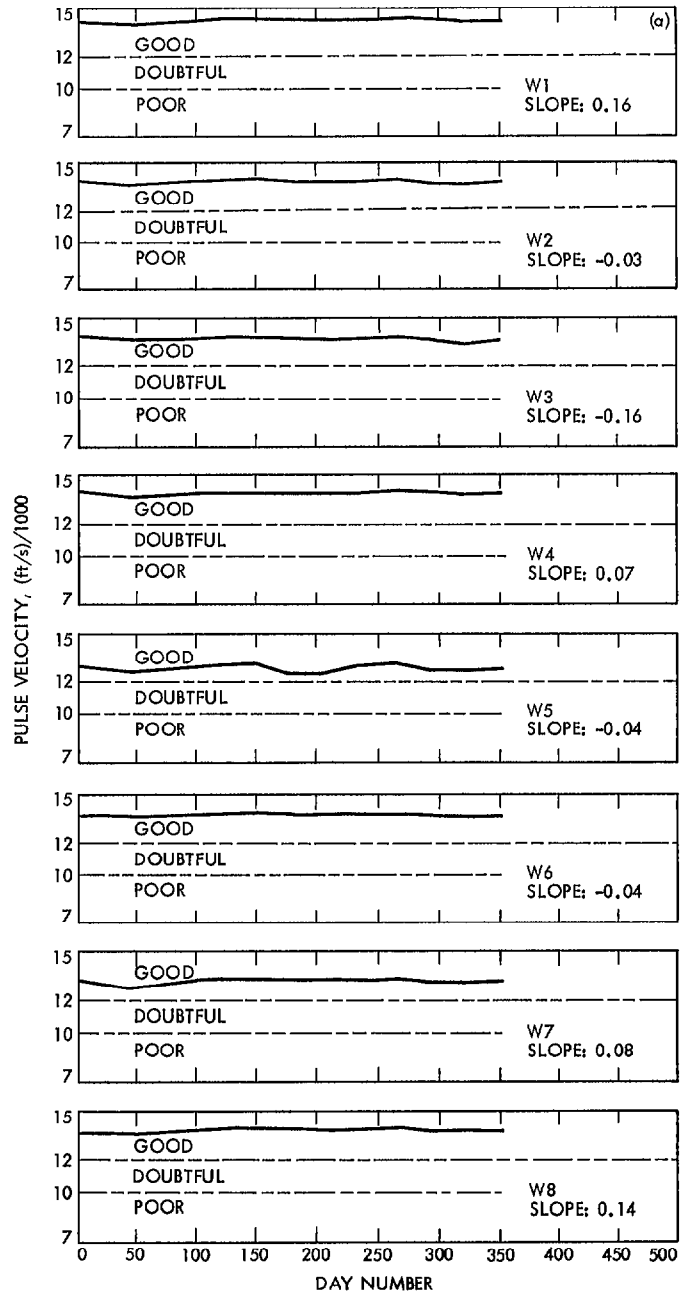
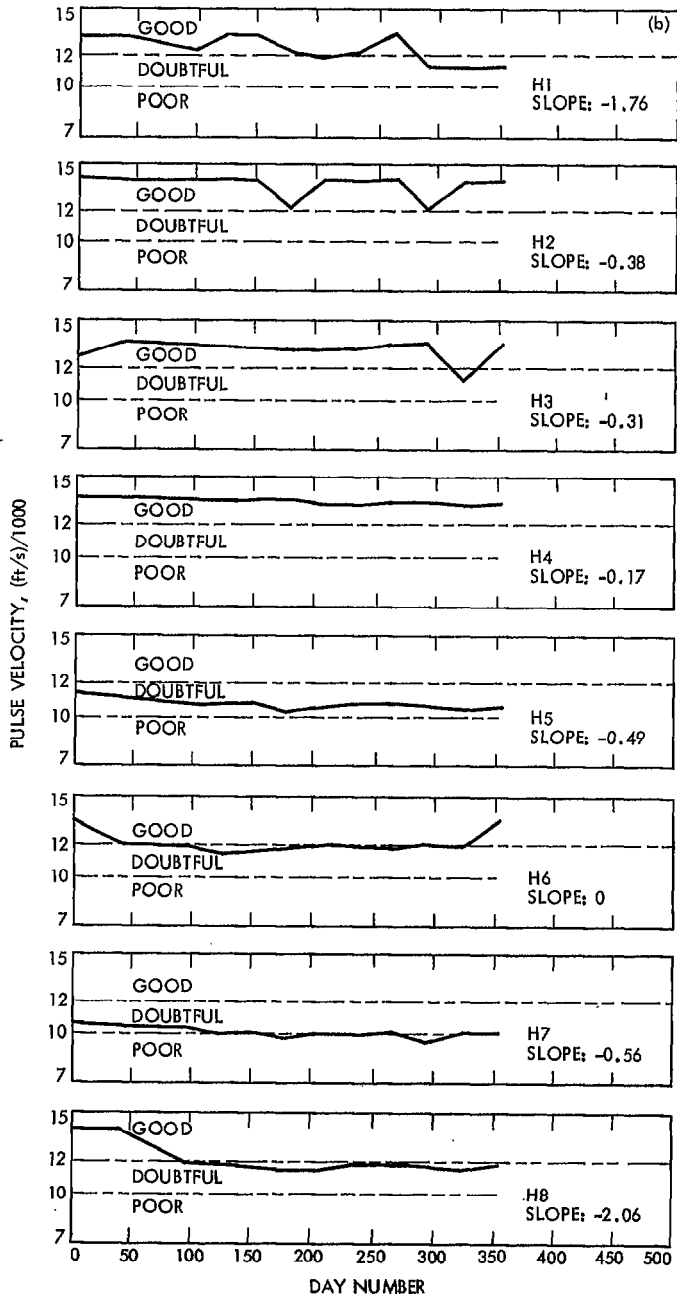
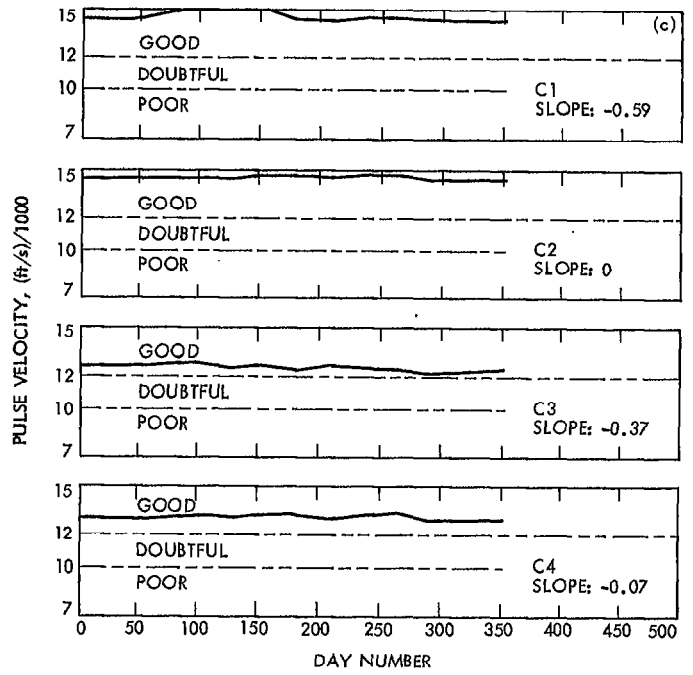
Fig. 4. DSS-14 pulse velocity readings of the (a) pedestal wall, (b) pedestal haunch, and (c) pedestal collar. Day 0 is July 21, 1982, and the slope is in units of (ft/s/year)/1,000.

The primary concerns were establishing what the minimum acceptable MOD E could be, and at what rate the MOD E was deteriorating. In addition to removing and testing core samples, a program of frequent measurements using ultrasonic test equipment was started. The velocity of ultrasonic waves through concrete is proportional to the MOD E, but no information regarding the absolute value can be obtained. However, it is useful for establishing a trend, and, used in concert with the other tests, might give some idea of the useful life of the pedestal. Figure 4 shows the results of these tests. In terms of pulse velocity, the haunch area under the runner was the poorest.

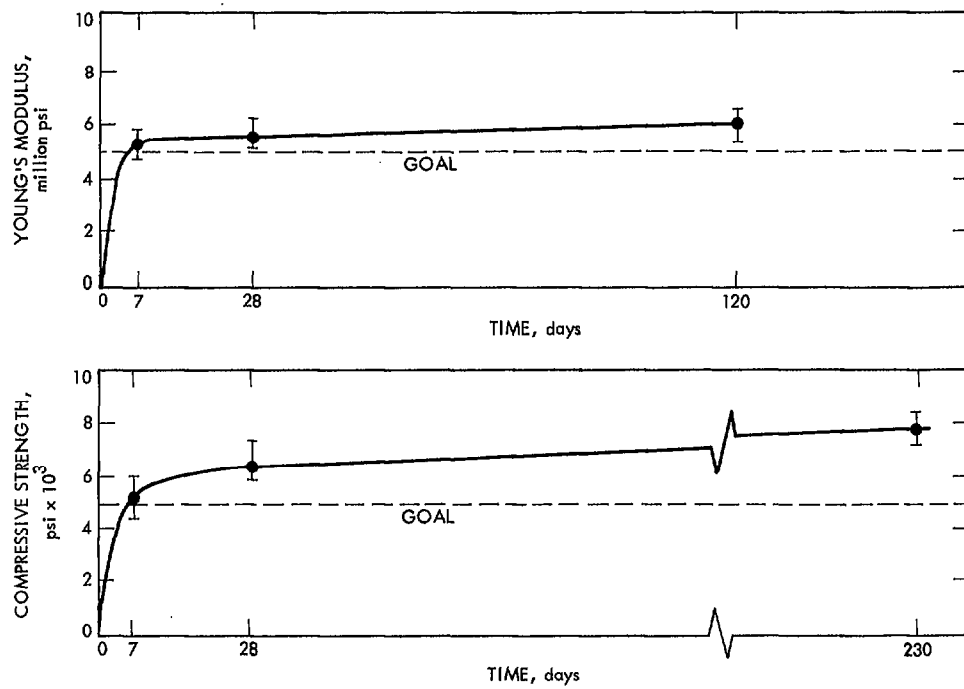
Fig. 8. Replacement concrete test results

Test cylinders were cast during the placement of the concrete and these cylinders were tested after cure times of 7, 28 and 60 days. The results of these tests show MOD E values well in excess of the 5 million psi specified. The test results are plotted in Fig. 8.
