Fault Identification Using Multidisciplinary Techniques at the Mars/Uranus Station Antenna Sites

A fault investigation was performed at the Mars and Uranus antenna sites at the Goldstone Deep Space Communications Complex in the Mojave desert. The Mars/Uranus Station consists of two large-diameter reflector antennas used for communication and control of deep-space probes and other missions. The investigation included interpretation of Landsat thematic mapper scenes, side-looking airborne radar transparencies, and both color-infrared and black-and-white aerial photography. Four photolineaments suggestive of previously undocumented faults were identified. Three generally discrete morphostratigraphic alluvial-fan deposits were also recognized and dated using geomorphic and soil stratigraphic techniques. Fourteen trenches were excavated across the four lineaments; the trenches show that three of the photolineaments coincide with faults. The last displacement of two of the faults occurred between about 12,000 and about 35,000 years ago. The third fault was judged to be older than 12,000 years before present (ybp), although uncertainty remains. None of the surface traces of the three fau

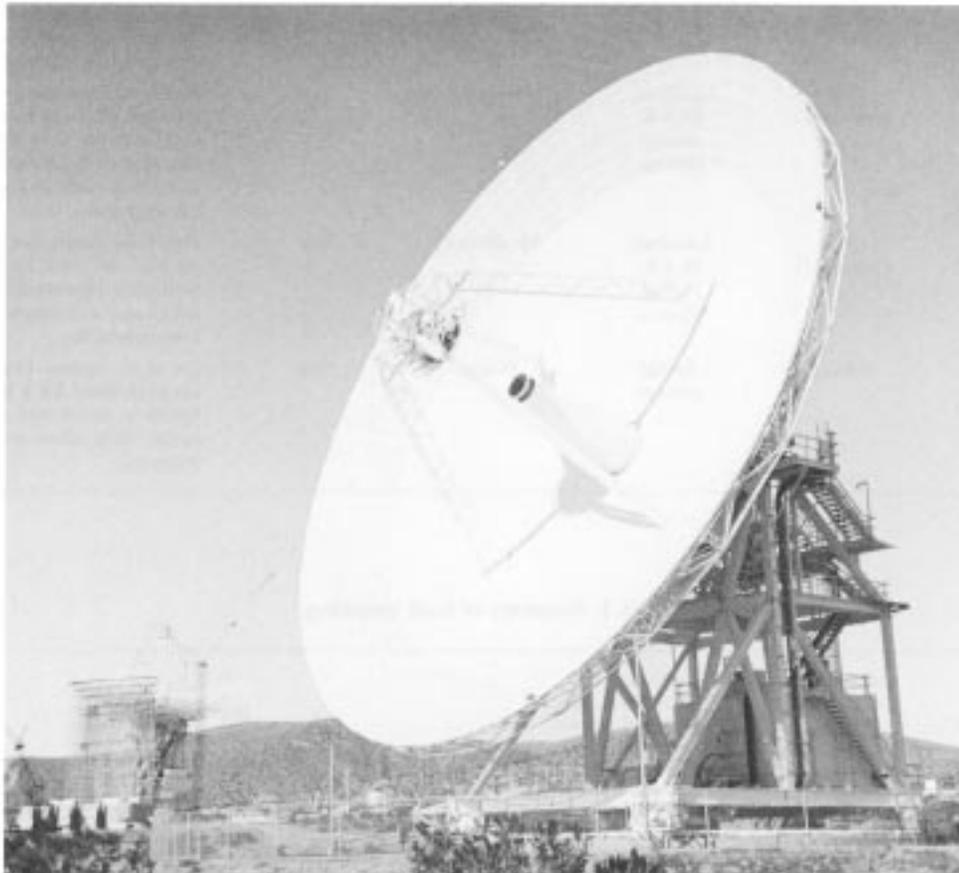
Fig. 1. The 34-m Uranus antenna (DSS 15). The 70-m Mars antenna (DSS 14) is in the background.

The Mars/Uranus Station consists of two antennas and surrounding support buildings (Fig. 1). The DSN 70-m antennas are the largest fully steerable communications

The Uranus antenna (DSS 15) is a 34-m, high-efficiency, precision-shaped antenna located approximately 487 m southeast of the Mars antenna (Fig. 1). Built in 1984, this

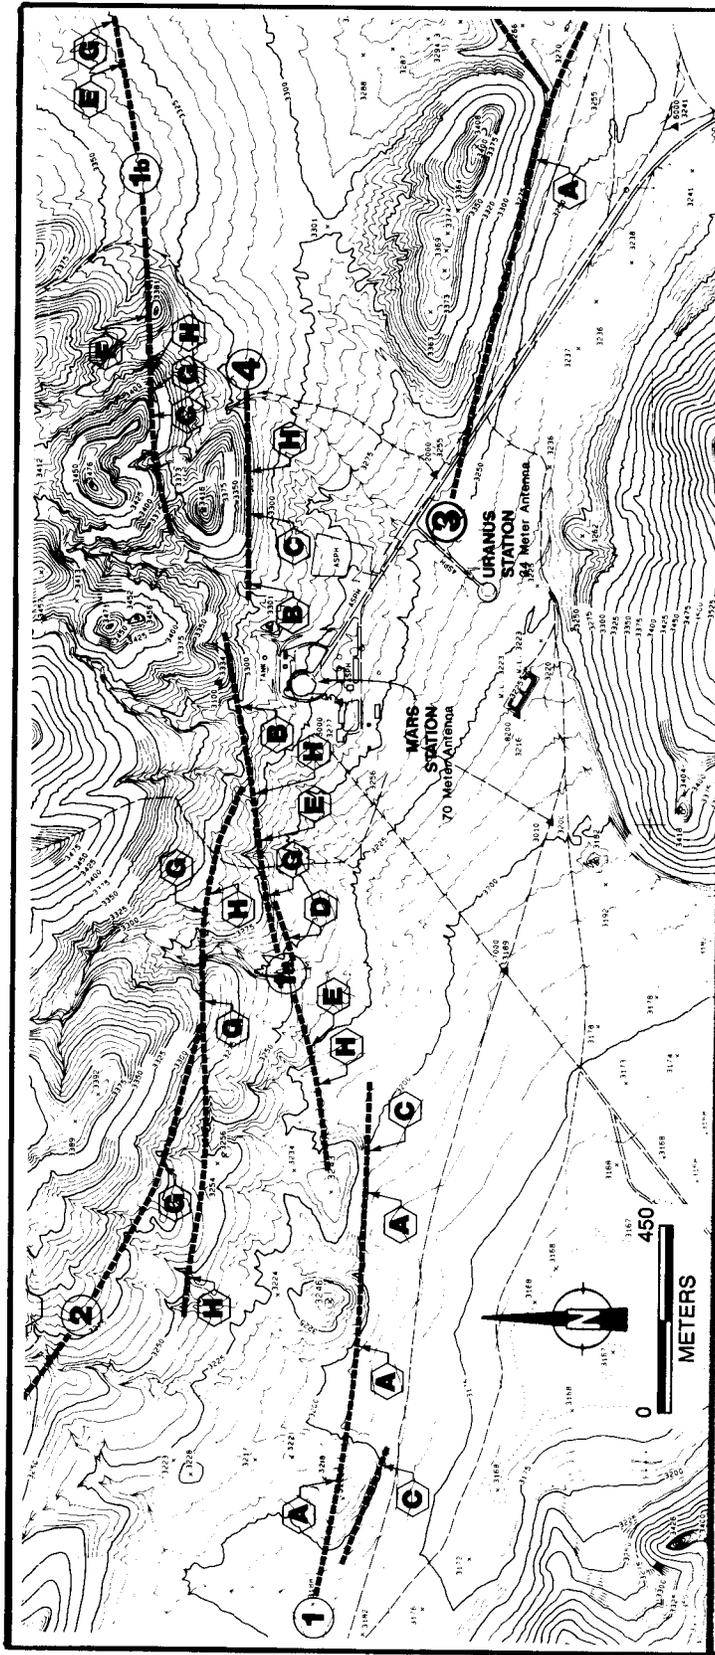
Fig. 5. Photolineament map of the Mars/Uranus Station valley.

GEOMORPHIC FEATURES RECOGNIZED DURING IMAGERY ANALYSIS: EVIDENCE OF PROBABLE QUATERNARY-AGE FAULTING

NUMBER AND APPROXIMATE LOCATION OF INTERPRETED PHOTOLINEAMENT, HEXAGON INDICATES LOCATION AND TYPE OF GEOMORPHIC FEATURE

Based on the photographic evidence and observations made during the field reconnaissance, four principal lineaments were identified and suspected to be associated with Quaternary faulting (Fig. 5). Figure 6 is a composite aerial photograph showing these lineaments. The characteristics of each lineament are compiled in Table 2.

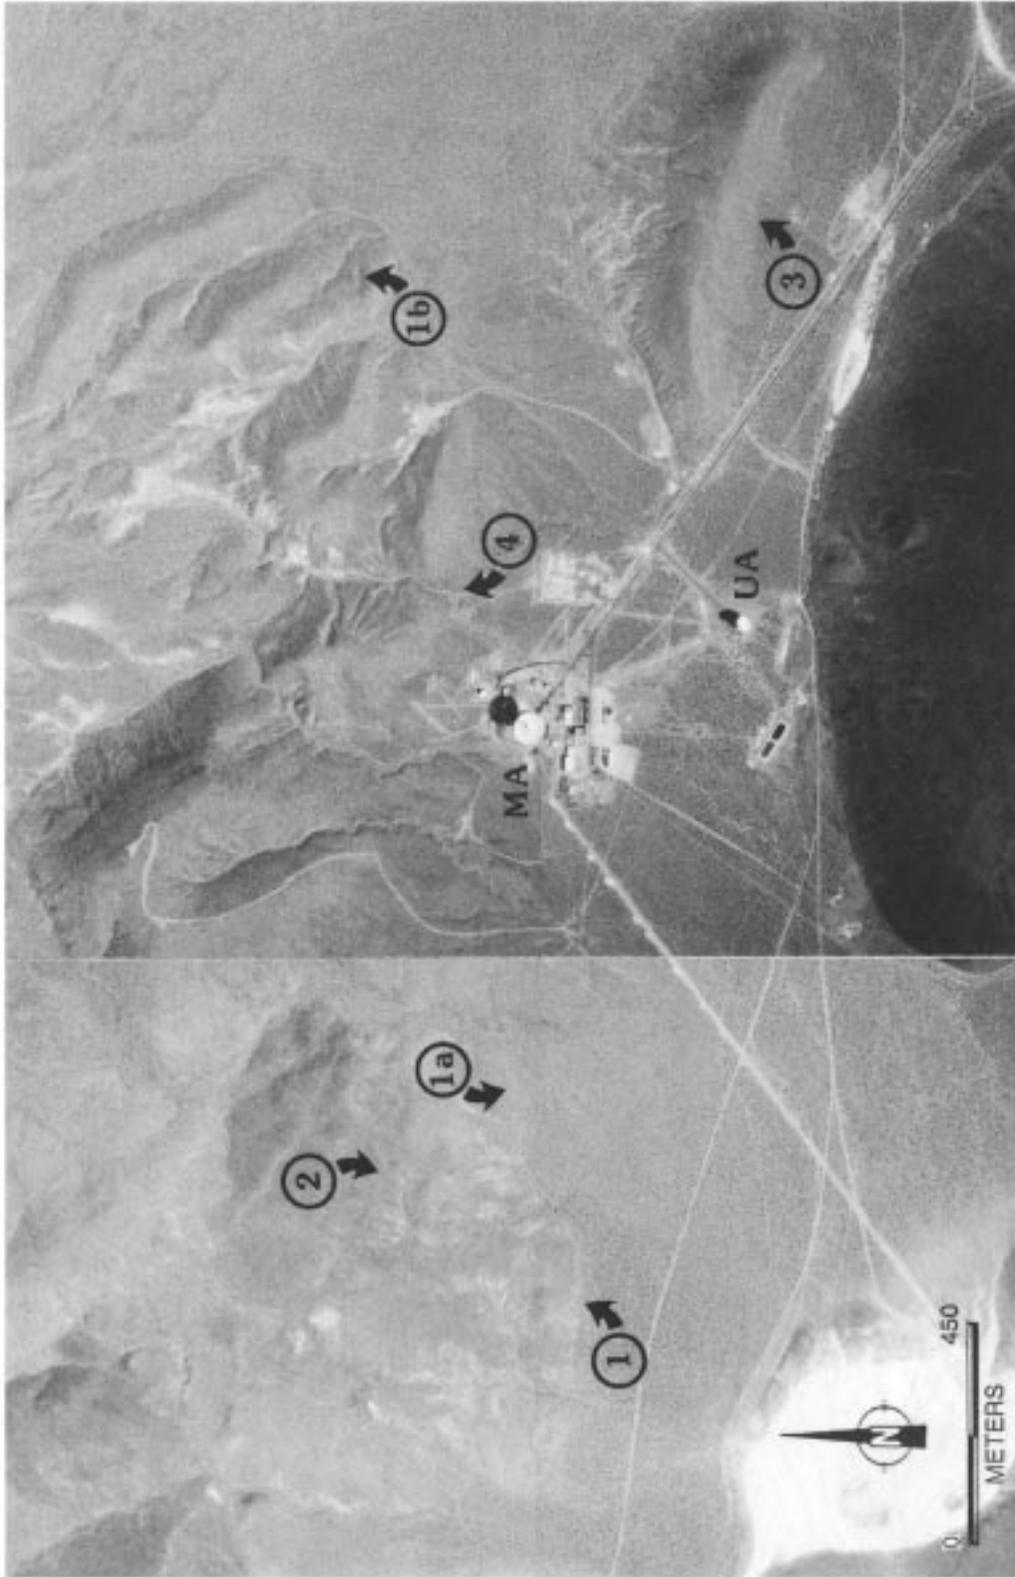
Fig. 6. Composite aerial photo of Mars/Uranius Station valley showing photographic expression of lineaments, with MA = Mars antenna and UA = Uranius antenna. Note the change in morphology and darker shade of alluvial-fan surfaces.

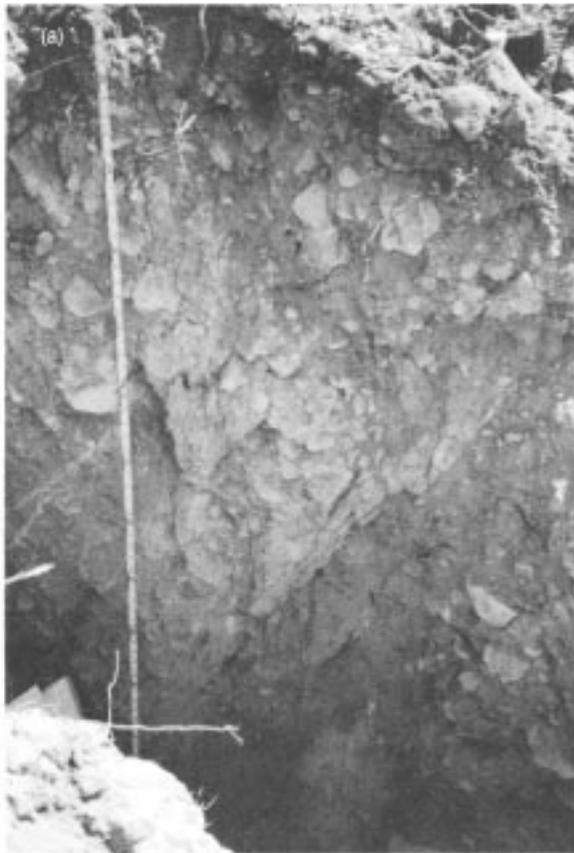
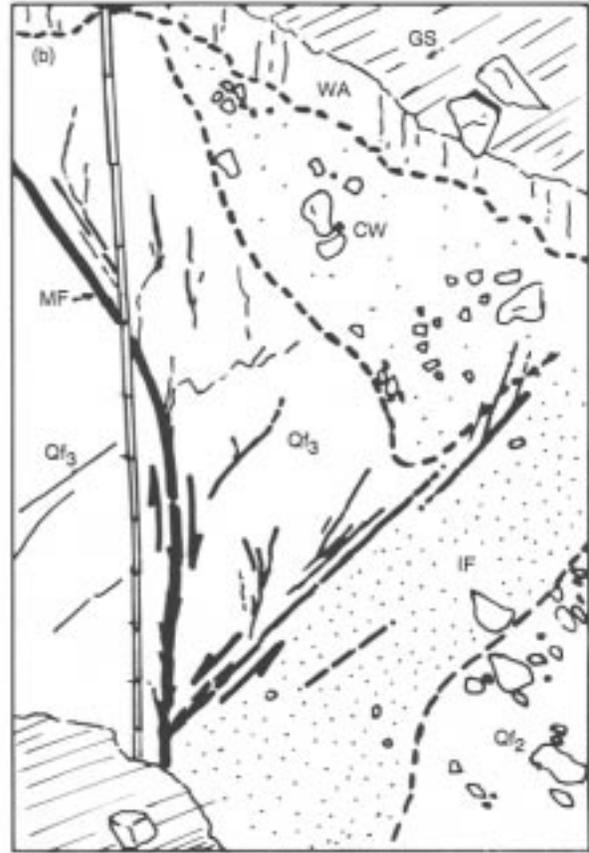
Fig. 8. Photo (a) and sketch (b) of fault observed in Trench 8 showing offset alluvial units and possible offset of scarp derived colluvial wedge. Qf_3 = Unit 3 fanglomerate, Qf_2 = Unit 2 alluvium, CW = colluvial wedge, WA = weathered alluvium below active geomorphic surface, IF = loose, fine-grained infilling, MF = main fault splay, and GS = ground surface. The folding rule is 1.8 m long.

The Photolineament 1 fault system is characterized by a zone of dislocation several feet wide. Movement has been typically accommodated along multiple slip surfaces and fractures. The slip surfaces generally dip steeply 60 to 90 deg to the south with the north side up. Minimum offset was in each case greater than the maximum trench depth, which varied from 1.8 to 3 m. Further, some fault-associated fractures extend into a colluvial wedge, presumably deposited on a scarp formed by an earlier faulting event (Fig. 8). This fact, combined with a minimum offset observed of least 1.8 to 3 m, suggests that the multiple movements have occurred on the Photolineament 1 fault system. However, no site-specific information is presently available from which to judge the recurrence of individual tectonic events.

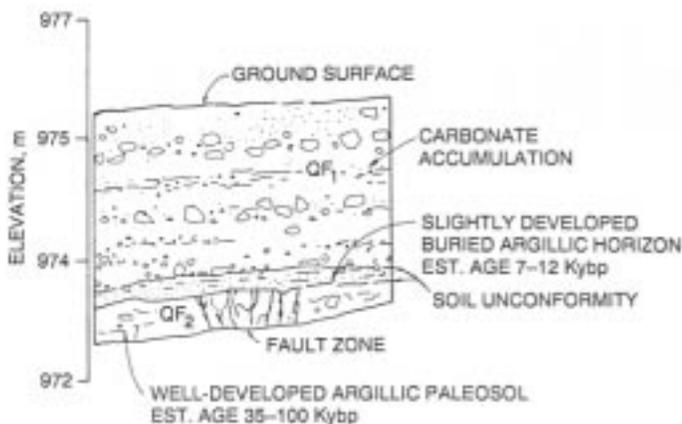
Fig. 9. Sketch of fault observed in Trench 9 showing diagnostic soil horizons used to bracket the age of most recent fault activity.

In Trench 11, the fault offsets a strongly developed buried argillic horizon in fan Unit 2 (Fig. 9). Based on relative profile development, this soil required at least 35,000 to 40,000 years to form; however, it may be much older [12]. Immediately above the fault at this location is a buried cumulic soil profile within fan Unit 1. The cumulic profile is characterized by a weakly developed argillic horizon (Btjk) with disseminated carbonate filaments. This soil is an estimated 7,000 to 12,000 years old [12] and is not offset by the Photolineament 1 fault. Accordingly, while not wholly definitive, the nondisplaced Unit 1 soil horizon exposed in Trench 11, the lack of any fault-controlled geomorphic expression in Unit 1 fans, and the subdued scarps characteristic of the older fans suggest that the last fault displacement most likely occurred in pre-Holocene time.

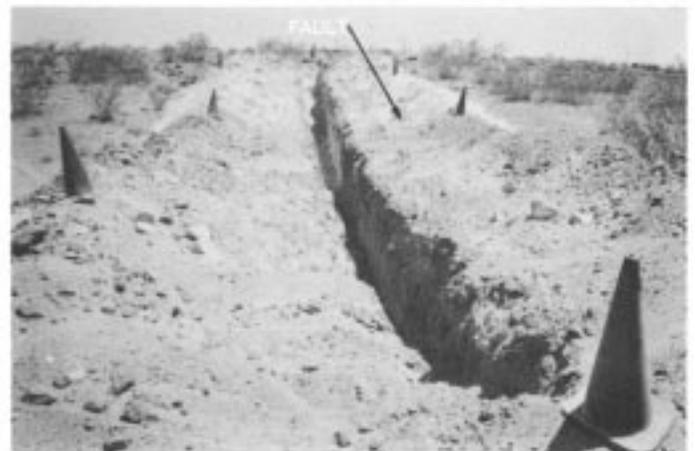
Fig. 10. Fault exposed in Trench 12 that juxtaposes Unit 2 and Unit 3 alluvium. Note color change at fault: Unit 3 is light colored, Unit 2 is dark colored.

Three trenches were excavated across the trace of Photolineament 3 (Fig. 7). Trench 12 exposed a fault that displaces Unit 2 and Unit 3 alluvium (Fig. 10).

Trench 13, located east of Trench 12, exposed both unbroken Unit 2 alluvium and a buried paleosol estimated to be at least 35,000 to 45,000 years old. These fault-paleosol relationships suggest that the last displacement of the Photolineament 3 fault occurred between about 35,000 to 100,000 years ago.
